Winter 2020 Volume 06 Number 04 ISSN 1468-9340

probe and prevent

Raul Risi, TTK, France,

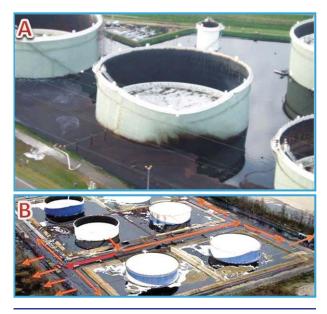
On 25 October 2005, an accident occured at an oil storage terminal in Kallo, Belgium. The terminal contained seven storage tanks, in a large bund made with earth dykes (image A, Figure 1). The accident was presented in a technical report in France's Analysis, Research and Information on Accidents (ARIA) database.³

Figure 1. Rupture of crude oil storage tank in Kallo (a) and in Ambès (b).

During the operational life of D2 a gutter was formed in the bottom of the tank. This gutter is situated at a distance of 1.5 m from the tank shell. Due to the formation of the gutter, water could no longer flow into the drain water system to be removed. The accumulation of stagnant water in the gutter caused strong corrosion, which significantly reduced the thickness of the bottom plates in that area.

The release initially started with a small leak, which was not visually detected. In the second phase of the accident the resistance of the foundation under the tank was greatly reduced locally (as a result of the fluidisation of the sand bed) and, due to the hydrostatic pressure of the crude oil on the tank bottom, the bottom ruptured over the length of the gutter. The force of the discharged crude oil was sufficient to destroy a part of the tank foundation and sweep away a part of the underground.

This accident, also presented in a technical report by ARIA, occurred on 12 January 2007 at a depot for oil and petroleum products comprising 28 tanks.⁴ The depot is located along the banks of the Garonne River, in an area in Ambès containing 'jalles', or pits and swampy channels (image B, Figure 1).

On 12 January 2007, at 8:00 am, a portion of the tank bottom broke and the full crude oil inventory spilled in a matter of a few seconds.

The storage tank bottom had last been inspected on 3 April 2006; the inspection method applied was a complete scan of the bottom according to the magnetic flux loss protocol. The accident report indicated thickness losses of between 20% and 50% over the central part; losses of 20 – 80% on the periphery; and a likely 2-year life span for the tank bottom. As a consequence, repair work had been performed and then verified.
